To Reduce the Rate of Breakage of Periodontal Probe during the Central Sterile Service Department (CSSD) Sterilisation Process

National Dental Centre Singapore

Singapore Healthcare Management 2021

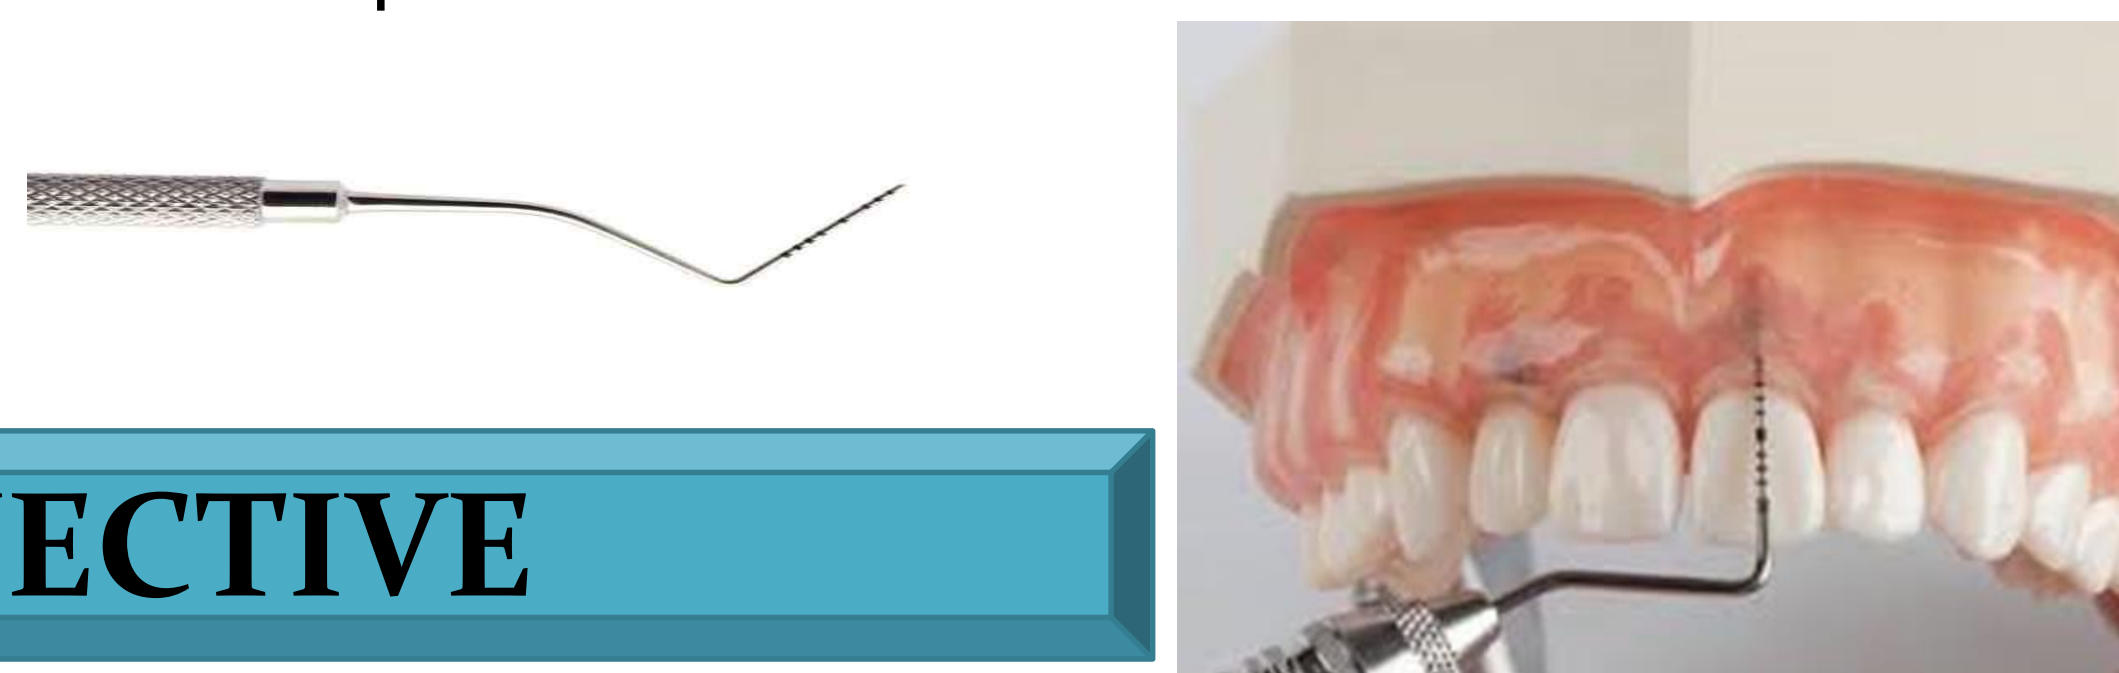
The perio probe is a common dental instrument which is used widely throughout the clinic levels. Due to its thin tapering end, it has a tendency to chip off or break off at the distal end.

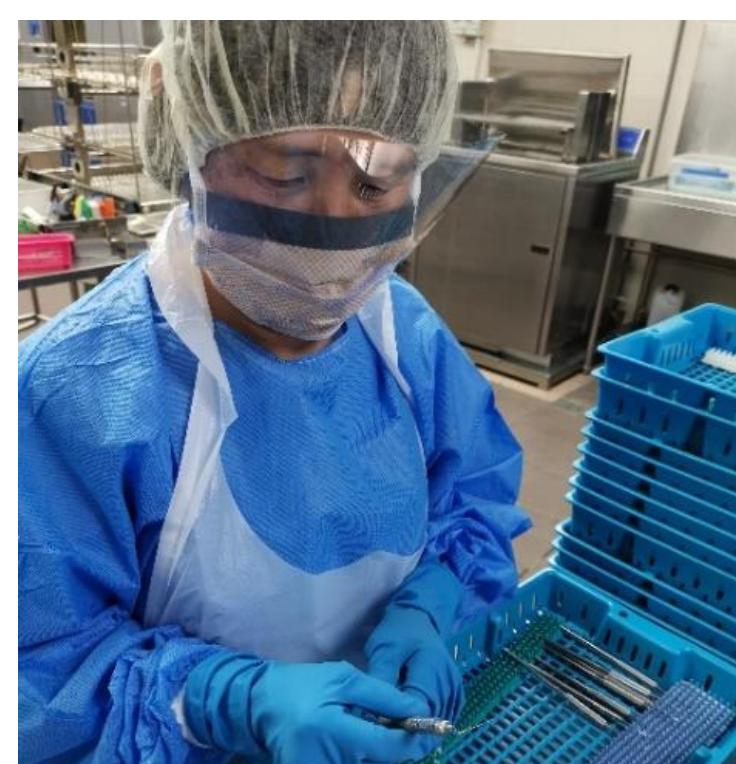
(1) Dirty Instrument receiving station

Incorporate checks for instrument breakages at 2 additional check points.

1. Dirty instrument receiving station
2. After washer station

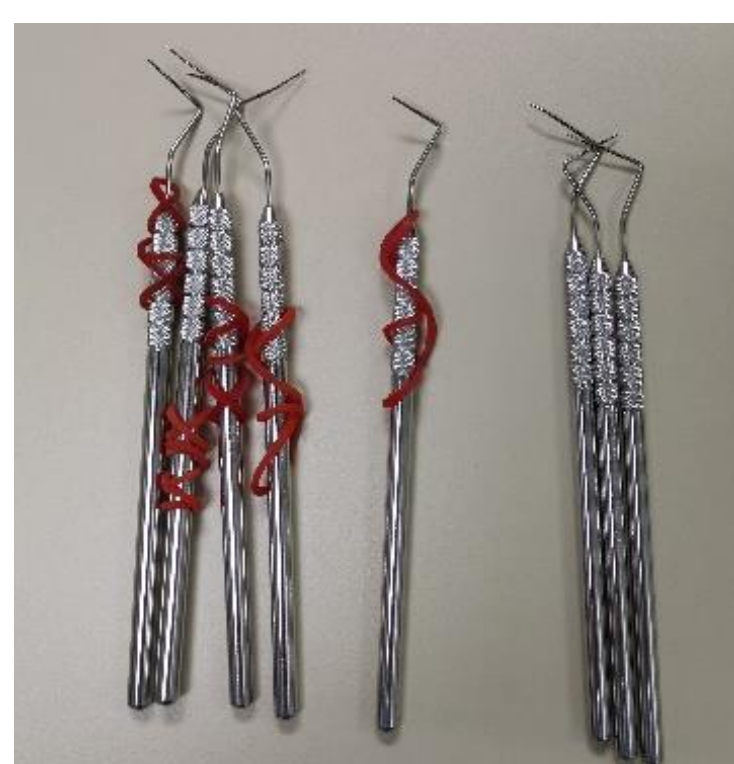
- (1) Perio probe that is received in broken condition, in the dirty instrument receiving station will be marked with rubber band.
- (2) Perio probe that is found broken after washer station will be segregated without rubber band.

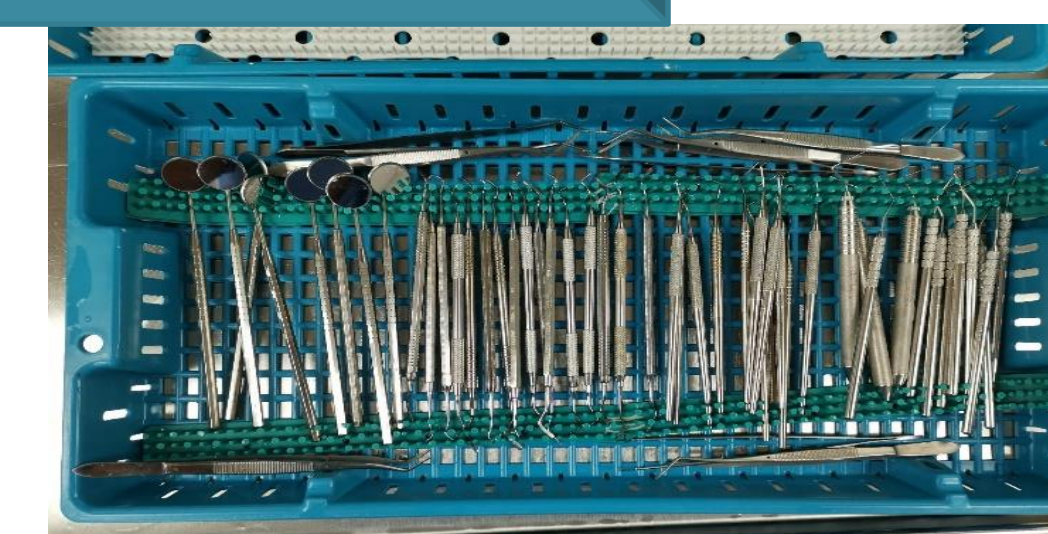
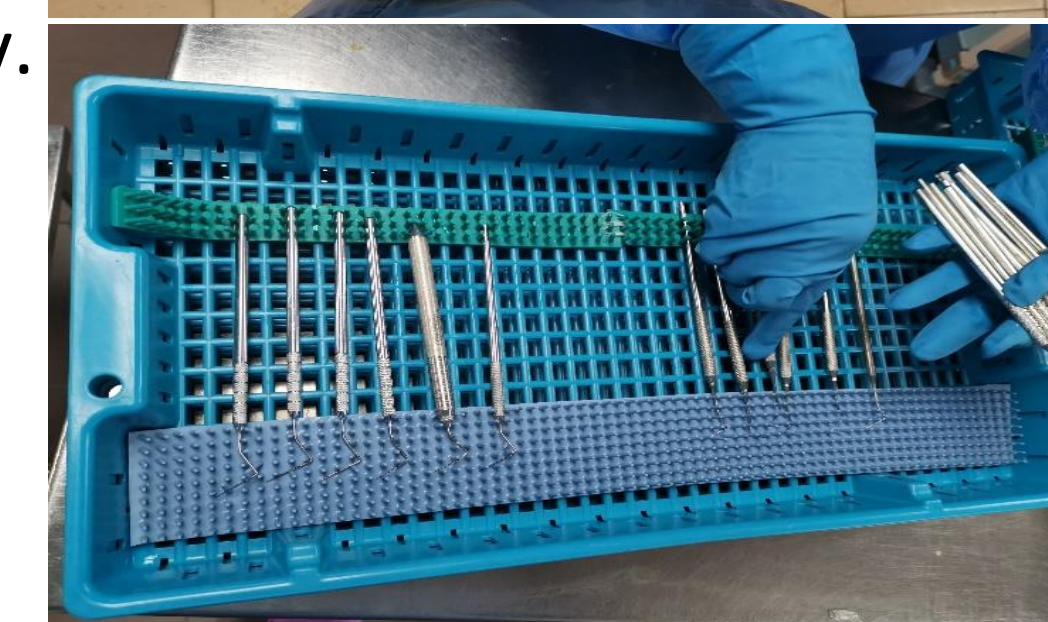
Segregate the Perio Probe from other instruments onto tray for washing.

To dedicate the space on the silicone mat for putting of sharp instruments.

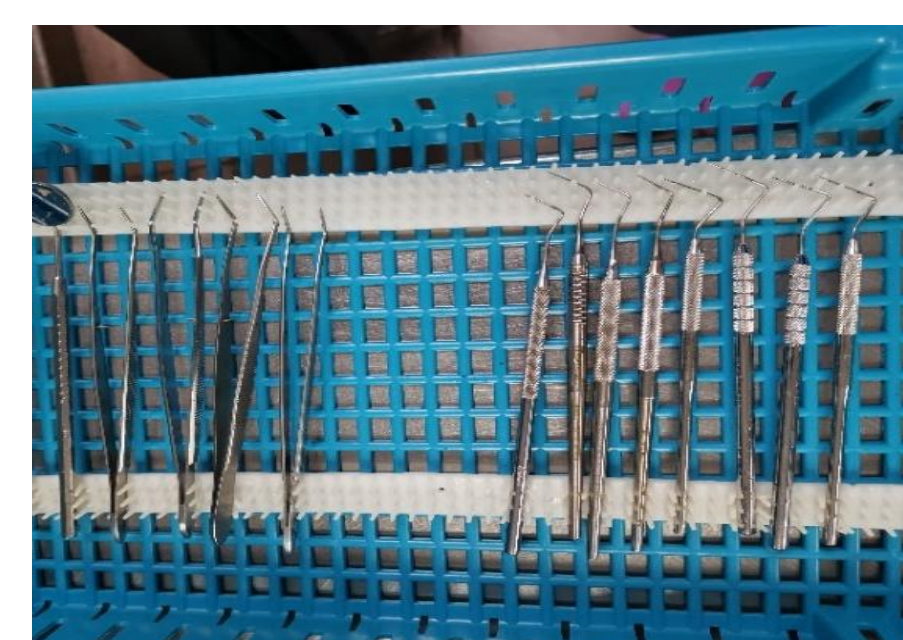
Before: The width of silicone mat used to hold perio probe in place in the washer rack is too narrow. In the process of transporting, perio probe may poke out of perforated holes and is prone to breakage.

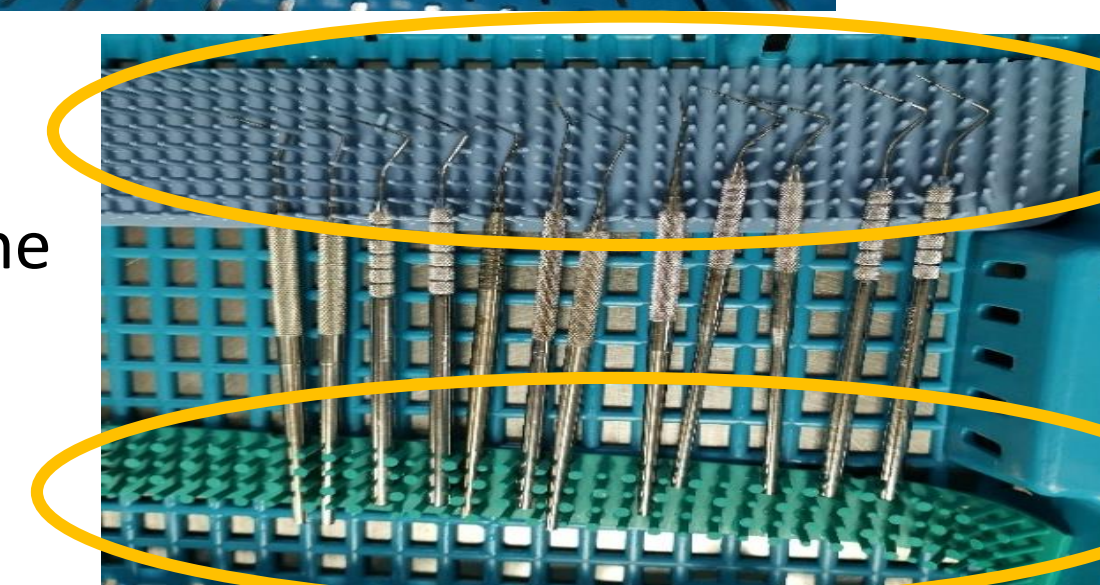
After: Silicone mat with broader width protects the tip of perio probe from breakage.

Increase the width of the silicone mat for placing instrument on tray for packing.
